Re: PCB Remediation Plan
125 Western Avenue Building Renovation Project
Harvard University- Boston, Massachusetts

PCB Remediation Plan

125 Western Avenue
Boston, Massachusetts

Harvard University

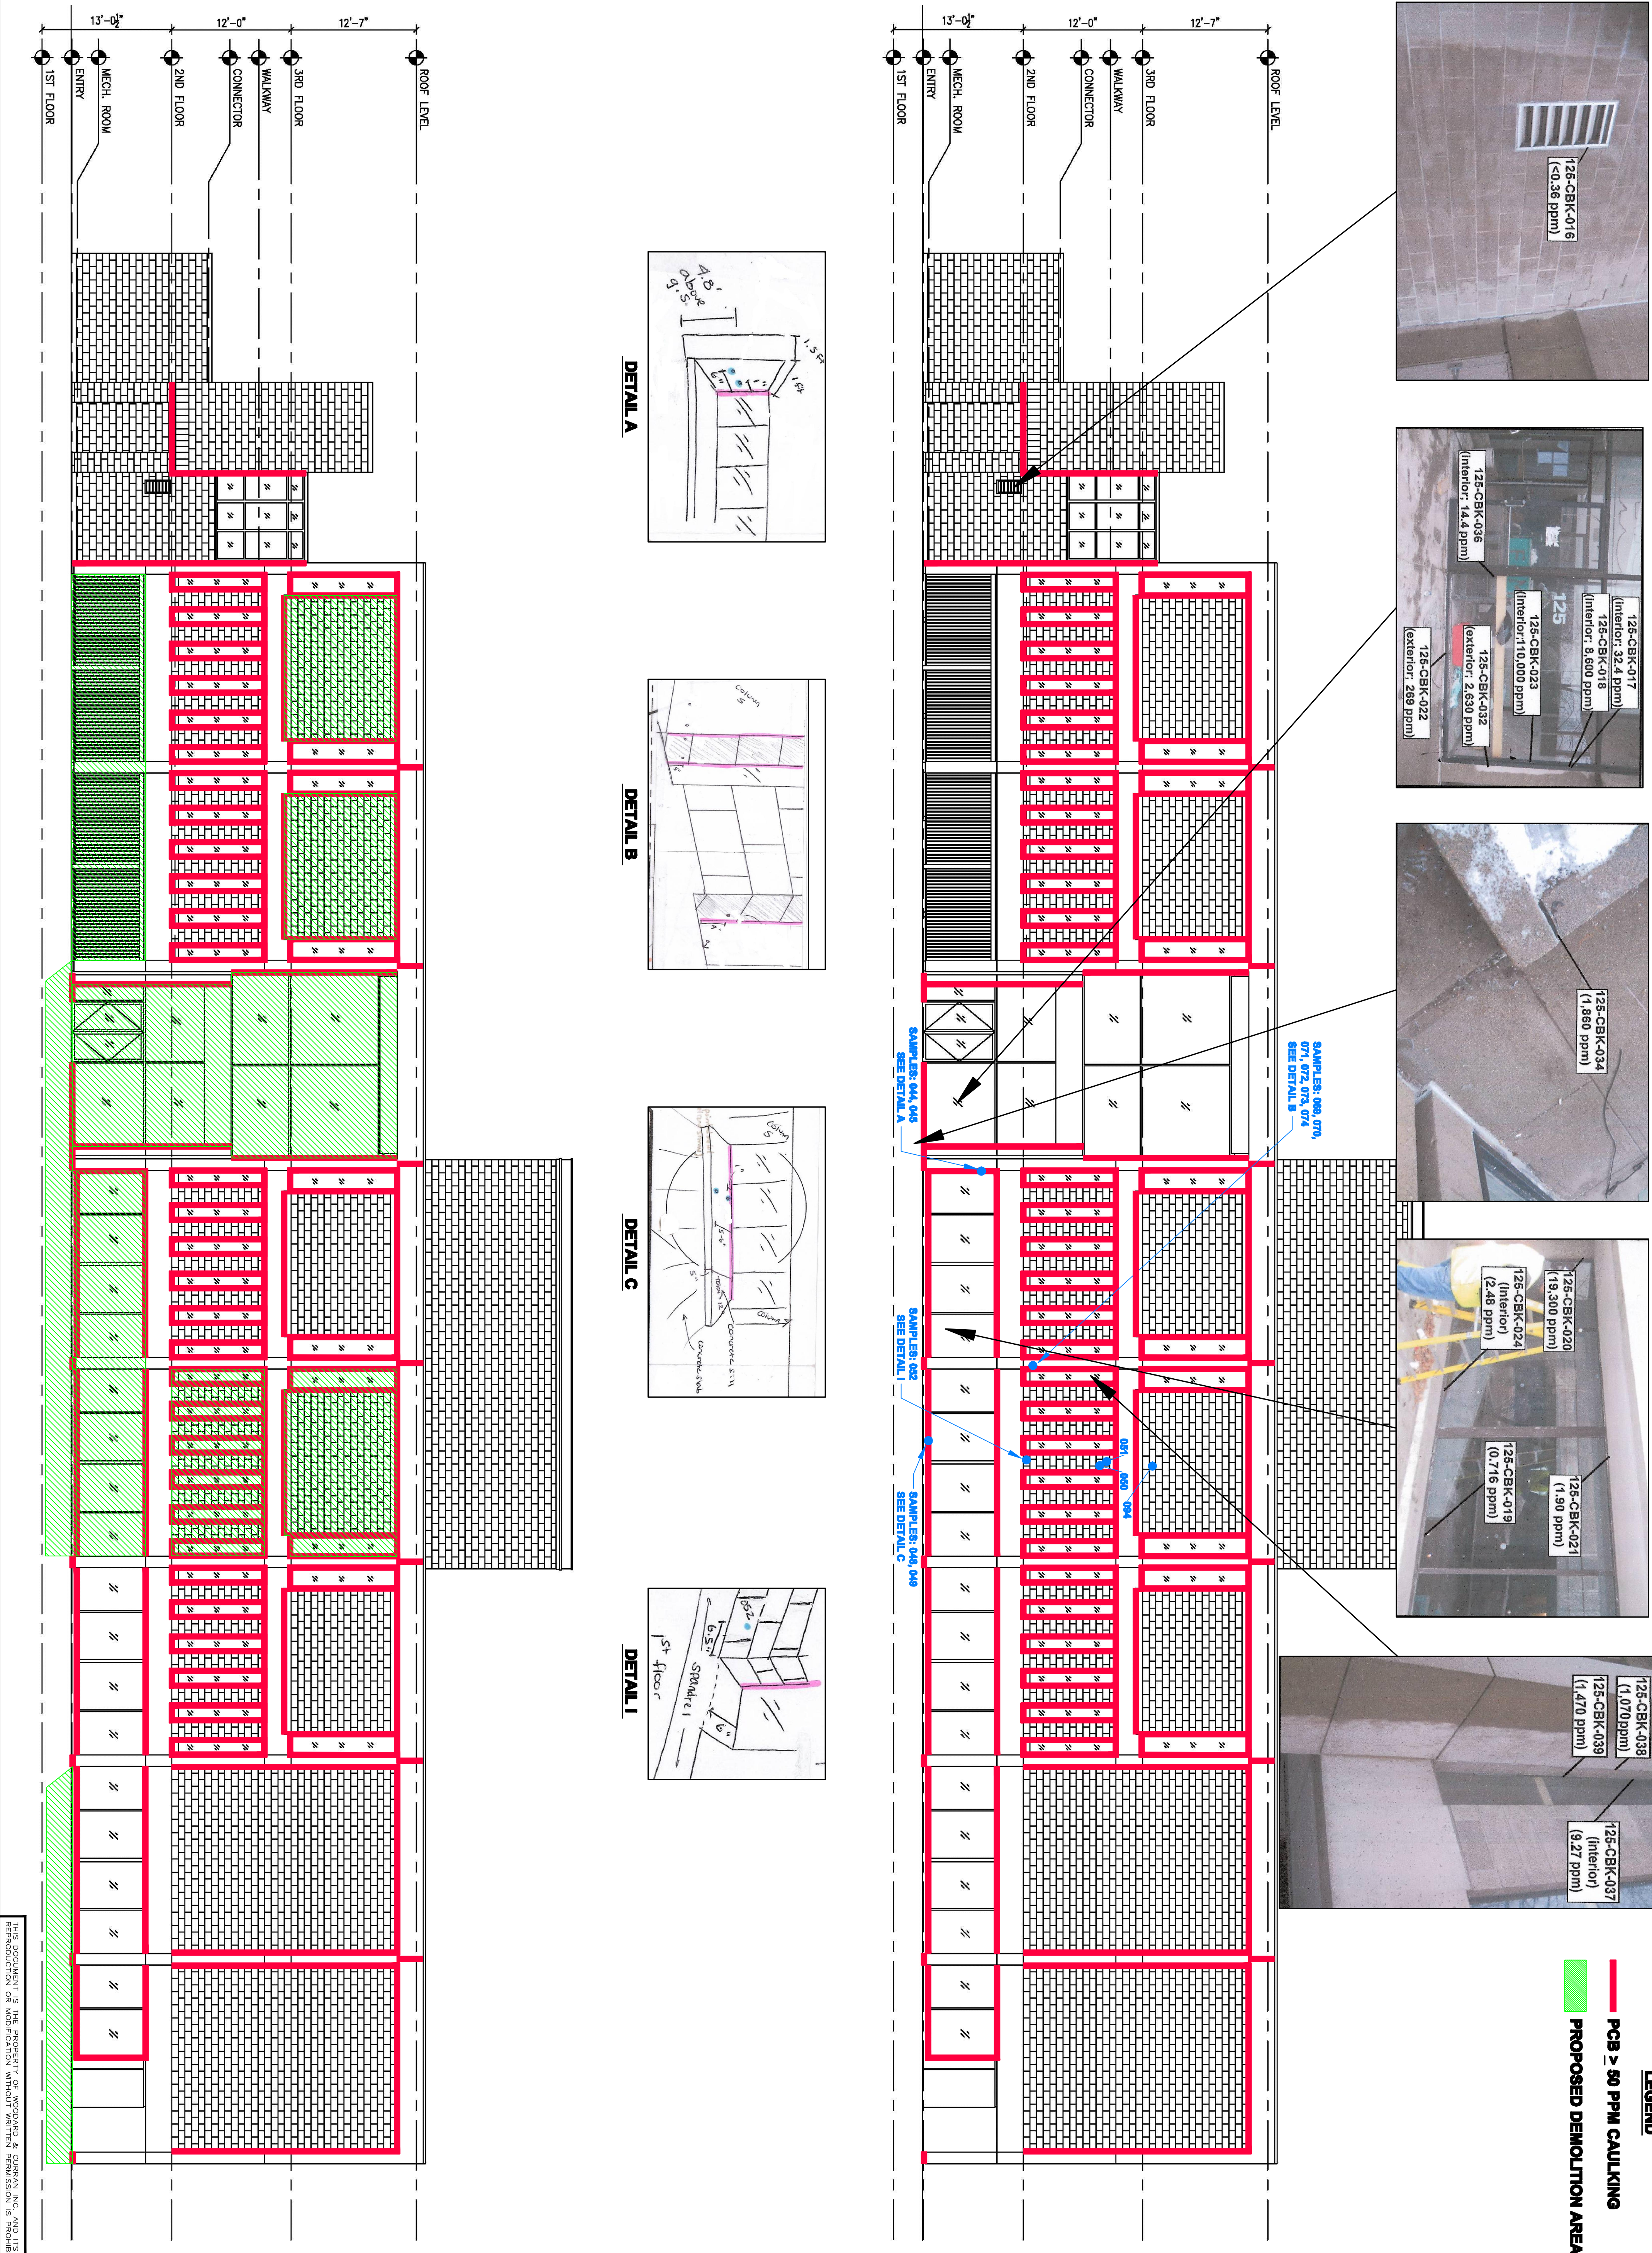
FIGURE 3

On the east façade elevation, caulking or other sealant materials were typically observed at select metal to concrete joints (e.g., caulking between a metal window frame and the adjacent concrete wall), and concrete to concrete joints (e.g., caulking between CMU block and structural concrete).

- Two types of metal to concrete caulking were observed on this elevation. For the first floor window caulking at metal to concrete, results were reported with PCBs < 1 ppm at a similar metal window joint on the north façade elevation (0.878 ppm). For the two emergency exit doors at the northern end of the elevation (2nd and 3rd floors), results were reported with PCBs > 1 and < 50 ppm at the metal to concrete perimeter joint (3.72 ppm).
- The concrete to concrete caulking result was reported with PCBs ≥ 50 ppm at the single joint type observed and sampled on this façade; a result of 3,600 ppm was reported for a CMU to structural concrete sample between the 2nd and 3rd floors. The CMU to concrete caulking sampled on this façade was visually similar to the CMU to concrete caulking also observed and sampled on other façades.

- CMU block above a horizontal caulked joint (structural concrete below CMU) – 1 sample. The result was reported with PCBs at 8.65 ppm at a distance of 0-1 inches above the joint (adjacent to caulking).

- CMU block below a horizontal caulked joint (structural concrete above CMU) – 2 samples. Both samples were reported as non-detect for PCBs as PCBs were not detected above the laboratory's minimum reporting limits (< 0.033 ppm). These samples were collected at distances of 8-9 inches below the joint (beyond one full block width) and at 16-17 inches below the joint (beyond two full block widths).

- CMU block beside a vertical caulked joint (structural concrete beside CMU) – 2 samples. PCBs reported at 0.215 ppm at a distance of 16.5 inches from the joint (the first accessible half-block after a recess adjacent to the caulked joint), and as non-detect (PCBs < 0.033 ppm) at a distance of 24 inches from the joint (the first accessible full block after a recess adjacent to the caulked joint).

- CMU within the perimeter of a scheduled CMU removal area – 16 samples collected on a 5-foot grid in support of a "cut-line" approach for segregation and disposal under 40 CFR 761.61(b). All 16 samples were reported as non-detect for PCBs (various reporting limits ranging from 0.091 to 0.100 ppm) at a distance of 8-9 inches from the caulked joints (i.e., the proposed cut line in the nearest mortar joint beyond caulking).

- Structural concrete above a horizontal caulked joint (CMU below structural concrete) – 2 samples. PCBs reported at 0.281 ppm at a distance of 0-1 inches from the joint (adjacent to caulking on the underside of an overhang), and as non-detect (PCBs < 0.033 ppm) at a distance of 3.5-4 inches from the joint (beyond a 90-degree corner to a vertical face).

- Structural concrete below a horizontal caulked joint (CMU above structural concrete) – 1 sample. PCBs reported at 1.47 ppm at a distance of 0-1 inches below the joint (adjacent to caulking) on a flush building face.

- Structural concrete beside a vertical caulked joint (CMU beside structural concrete) – 2 samples. PCBs reported at 0.098 ppm at a distance of 4-5 inches from the joint (before a 90-degree corner), and at 0.113 ppm at 6.5-7.5 inches from the joint (after a 90-degree corner).

As described further in Section 3 of this Plan, the scope of renovation work for this elevation includes select window removal, CMU block and concrete panel removal, CMU block cleaning and painting, and asphalt and soil removal. Results of the building material characterization samples collected in support of this renovation scope are discussed below; sample locations are depicted on Figure 3.
